REPORTS OF DAMAGE
TO JAPANESE WARSHIPS - ARTICLE 2

YAMATO(BB), MUSASHI(BB),
TAIHO(CV), SHINANO(CV)

U.S. NAVAL TECHNICAL MISSION TO JAPAN

6 January 1946

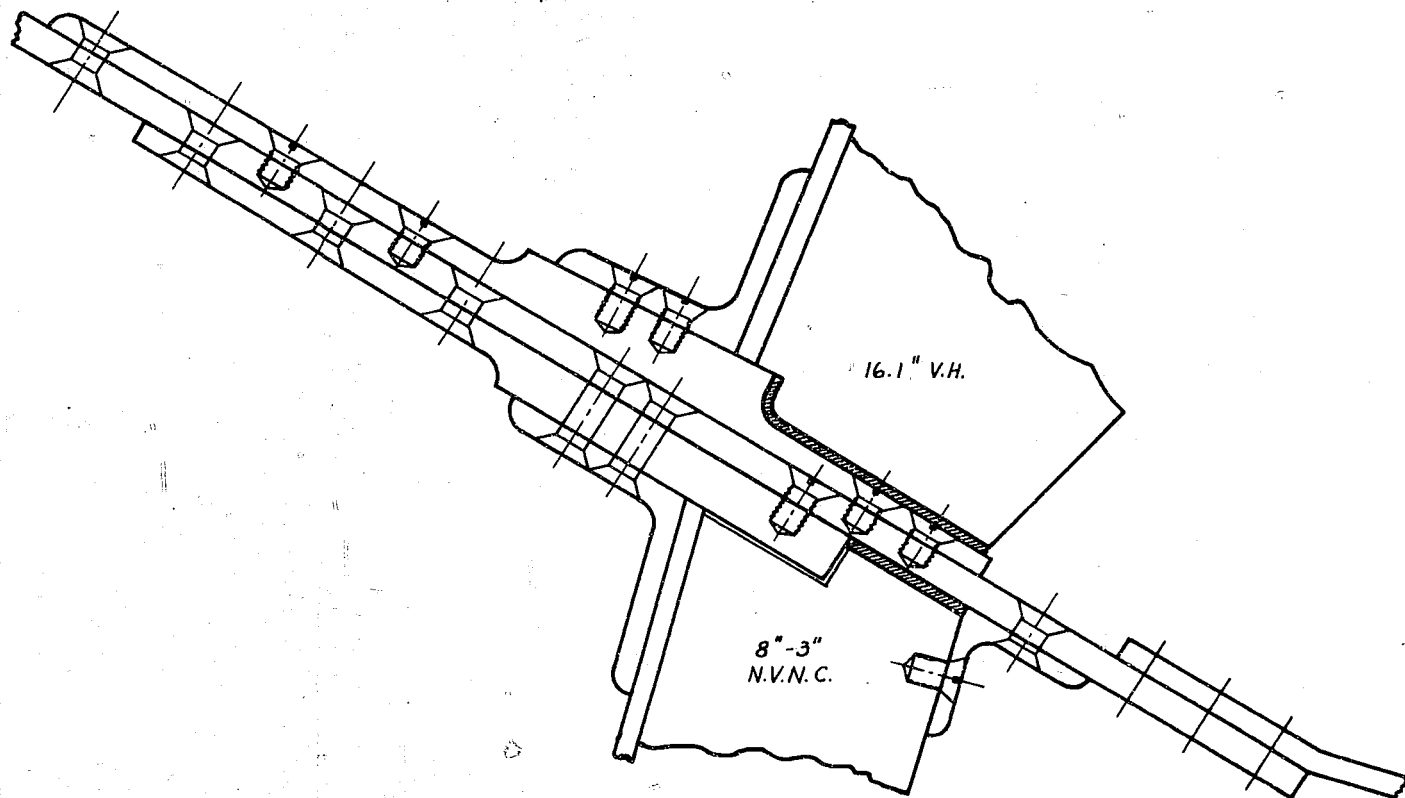
PLATE I 1 JAN. 1946

a. The connection joining the upper main belt to the lower section undoubtedly would be ruptured somewhat liberally, the seriousness of the rupture increasing with proximity to the joint. Thus, within reasonable limits, a deeper hit can be expected to cause a much more serious rupture of the joint than did this shallow hit.

ARMOR BELT CONNECTION ,
YAMATO CLASS

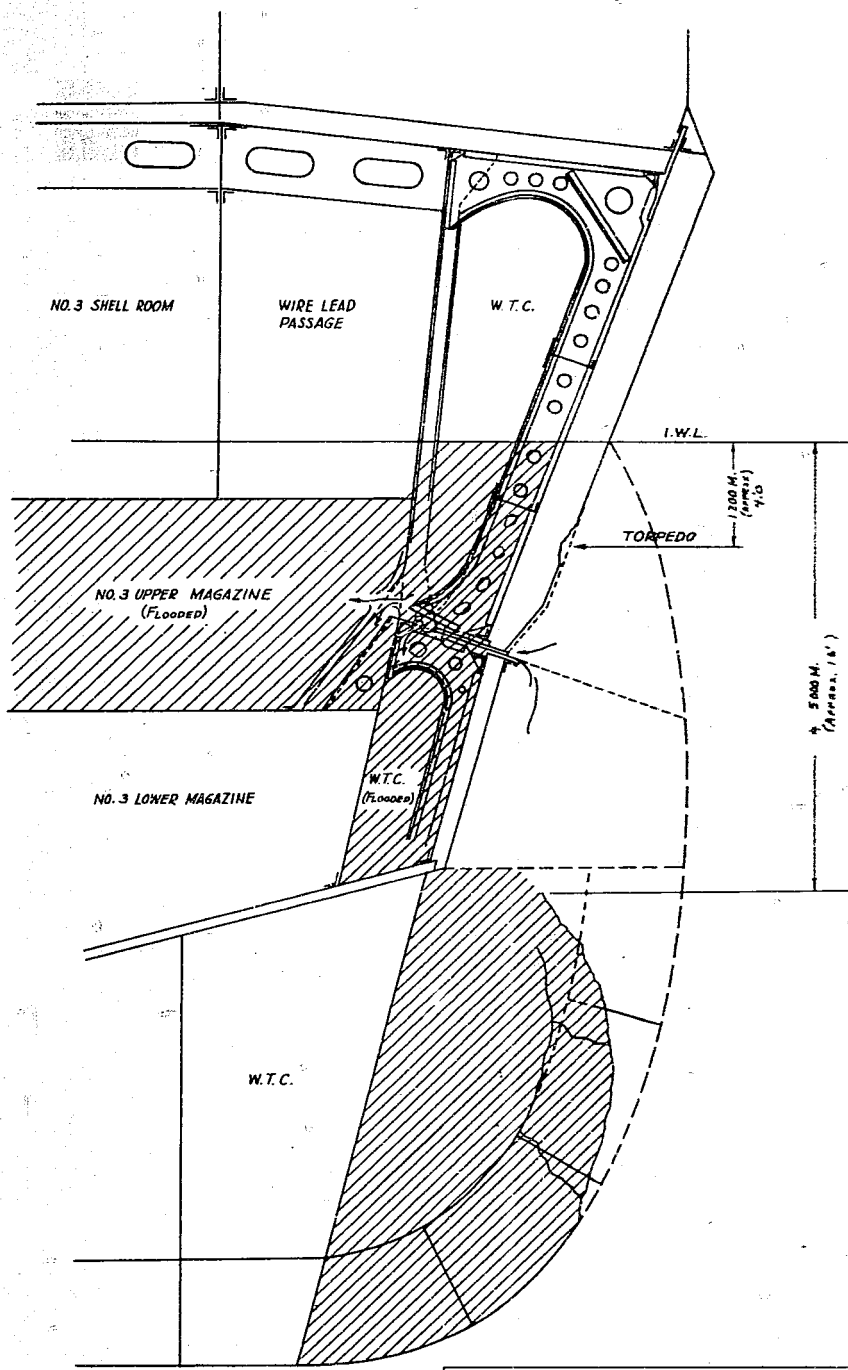
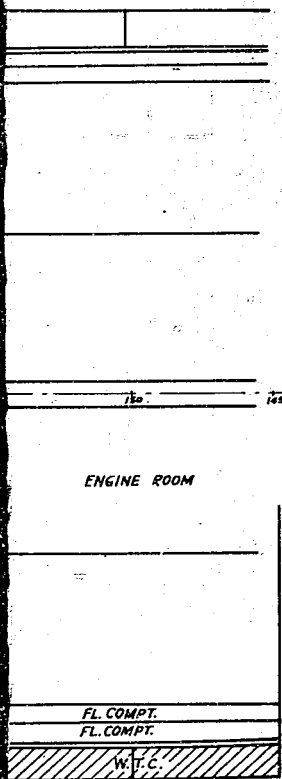
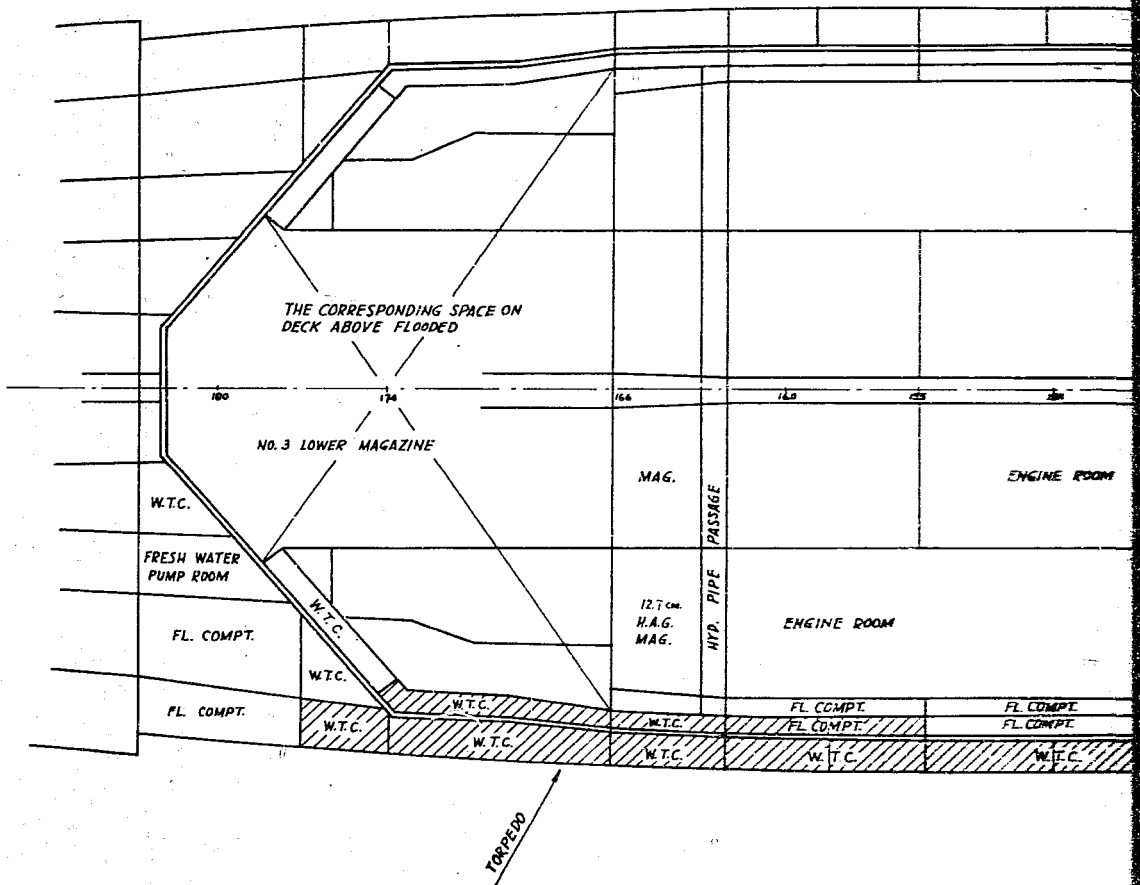
PLATE II
I JAN. 1946
YAMATO (BB) DAMAGE
NAV TECH JAP
TOKYO
APPROVED
C. C. Z.

On 25 December 1943, at 180 nautical miles north of Truk, at latitude 10°-5' N. and longitude 150°-32' E., one torpedo hit was received from a single enemy submarine. A hole about 5 meters (16 feet) depth, extending downward from the top of the bulge connection (at the armor) and 25 meters (82 feet) in length, between frames 151 and 173, was produced. Water flooded into the No. 3 (turret) upper magazine from a small hole in the longitudinal bulkhead caused by caving in of waterline armor. (Translation by U.S. Naval Japanese Language Officers).

13. It was found that the Fourth Section (Ship Construction) had made a careful inspection and analysis of the damage. Plate II has been traced from a drawing made by Japanese officers who inspected the damage. In turn, the Japanese drawing was made under close supervision of representatives of the U.S. Naval Technical Mission. Plate II is considered to be a reasonably accurate description of the damage.

15. Although the torpedo defense system of YAMATO in way of this hit is somewhat different from that in the middle one-half length (See Plate IV) and the torpedo struck quite shallow, (about four feet below the surface and in way of the main belt some distance above the joint between the upper and lower sections), it is possible to draw the following conclusions from this damage in case of torpedo hits by either U.S. aircraft or submarines (600 pound torpex warheads):

17. As a result of the Japanese investigation of this damage, the Fourth Section (Ship Construction) authorized the installation of a 45° sloping plate across the corner of the upper void between the two inboard bulkheads. This plate is shown on Plate IV, in the midship section. It ran the full length of the machinery spaces. The avowed purpose was to maintain watertightness of the void between the two bulkheads, but this measure seems hopelessly inadequate, and the Chief of the Design Branch openly expressed the opinion that it could not have been of any possible value.

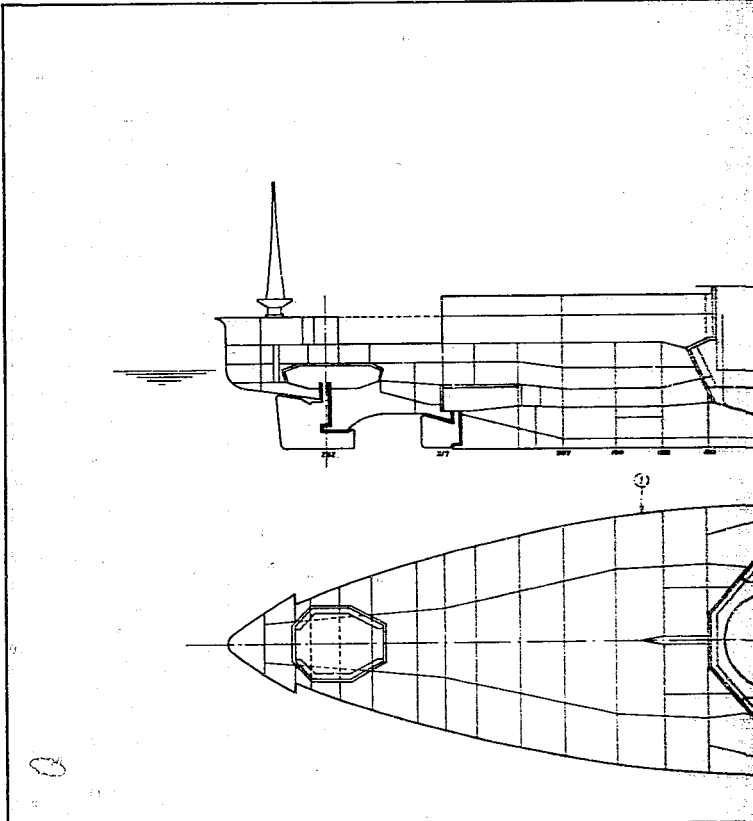
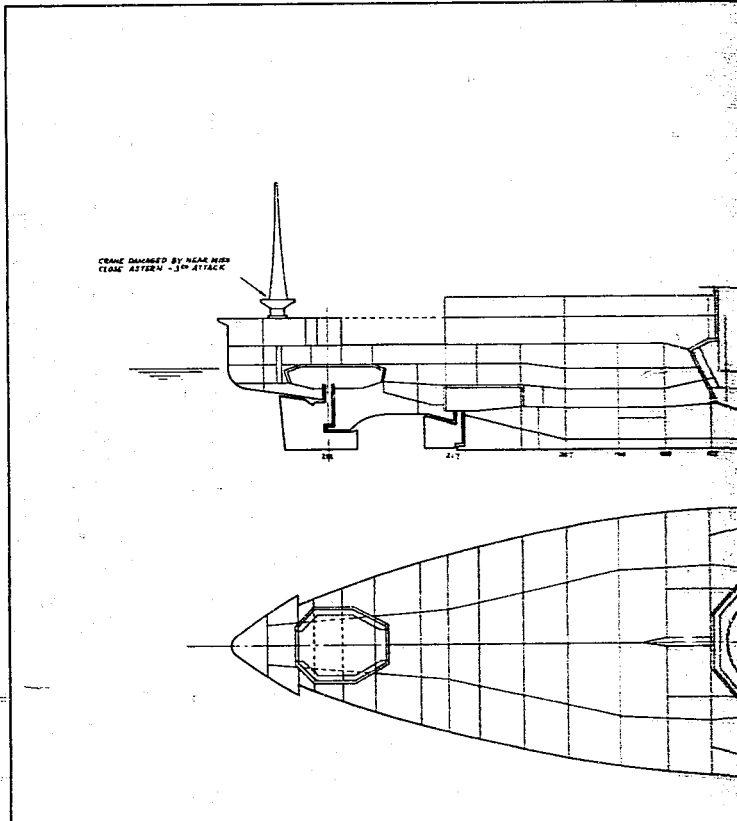
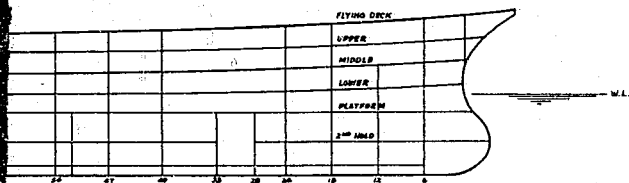
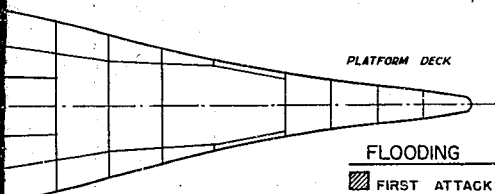
HITS ON YAMATO (BB)
7 APRIL 1945

21. The torpedoes striking on the port side caused immediate flooding of No. 8 and No. 12 firerooms, the port outboard engineroom and the port hydraulic machinery room. The Executive Officer reported that not more than 20 men (all enlisted ratings) escaped from these spaces at that time. This extent of flooding could indicate either three or four hits. The Assistant Gunnery Officer believed that the aftermost hit was close to the bulkhead at frame 143, which separated the port outboard engineroom and the port hydraulic machinery room, and thus caused flooding of the two spaces. Accordingly, three certain hits and one probable hit are shown on Plate III, as having occurred on the port side in this attack.

22. All three officers agreed that the starboard hit flooded No. 7 fireroom rather quickly, the torpedo having struck in the vicinity of frame 125. None of them knew of any other damage on the starboard side, although the Assistant Gunnery Officer vaguely recalled reports of a second starboard hit.

Plate III indicates the locations of the hits as given above. The frame numbers given are estimates, of course, for the purpose of showing points of impact. These might well have been some frames away from those listed. Overlapping of damage from hits on successive attacks seems to have occurred in two instances; i.e., in the vicinity of frame 150 port, and of frame 125 port, judging from the flooding of port inboard machinery spaces.

34. It will be noted that both possible hits were on the port side. It is considered doubtful, in view of the lack of information concerning them and the angles of list reported, that they occurred. The one probable hit in the second attack could well have occurred in the confusion of several torpedoes striking in the vicinity, more or less simultaneously.

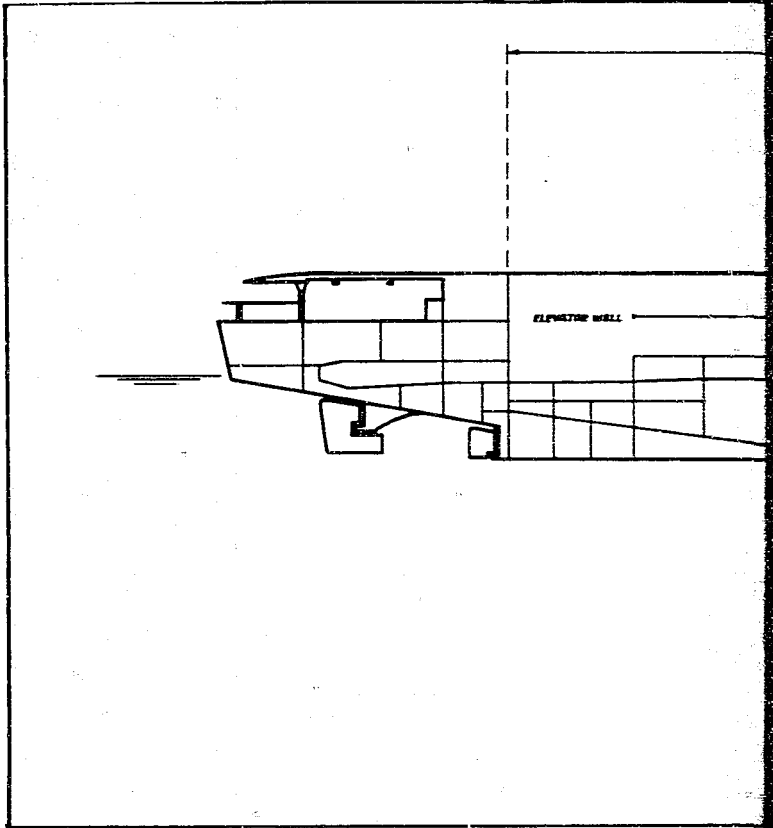
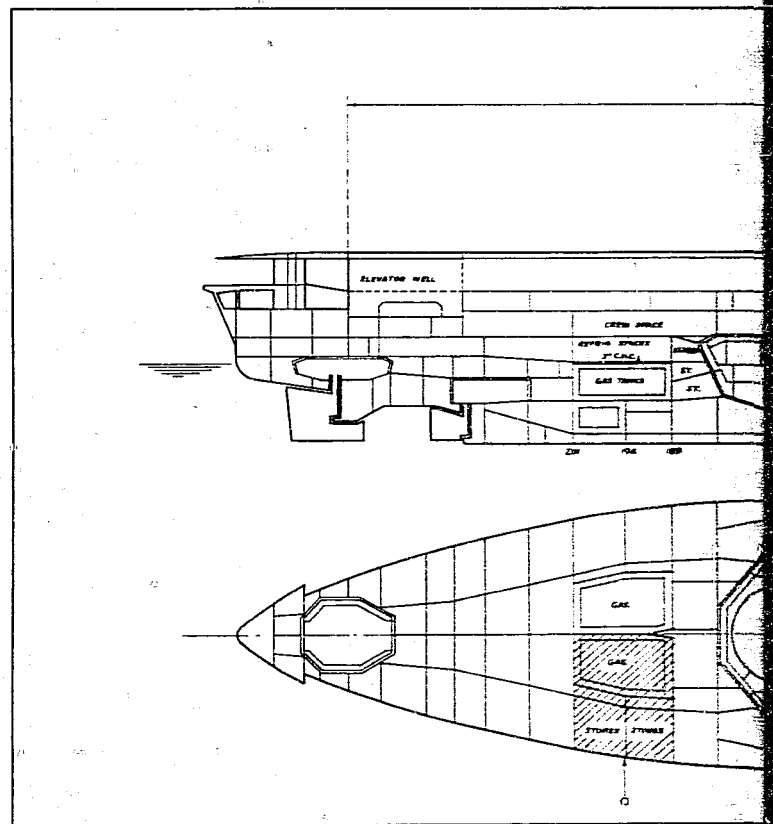
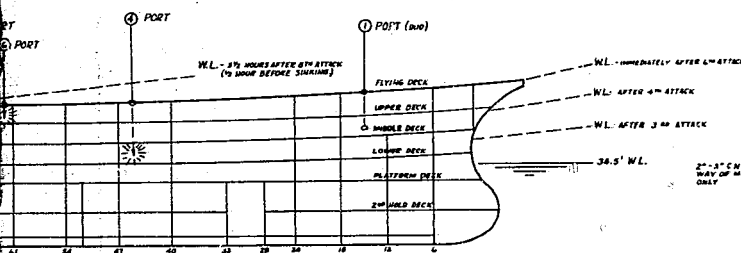
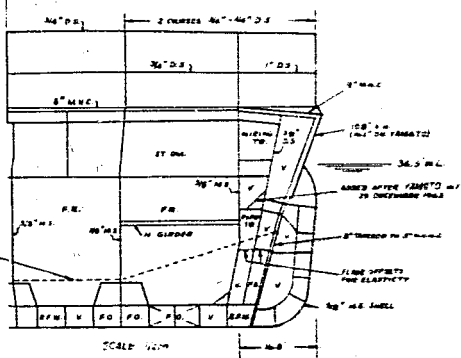
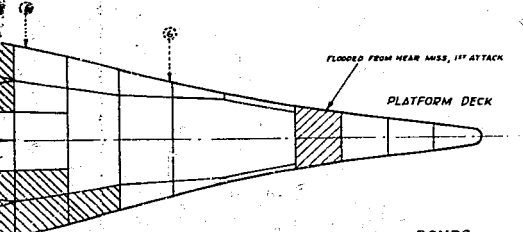
11. Three torpedo hits again were reported, this time all on the port side. The first struck near frame 143, close to the bulkhead separating the port outboard engineroom and the port hydraulic machinery room. The latter space started to flood at a rate somewhat beyond control, but not instantly. Minor leakage into the engineroom occurred, but this was not serious. This undoubtedly was a hit.

12. The points of impact of the other two torpedoes were reported at about frame 80 (in way of No. 1 turret), and about frame 110 (at the forward bulkhead of the forward port outboard fireroom). There was no damage or inboard flooding insofar as the two officers were aware. The list after this attack was negligible to port (it had been 1° starboard). It is considered that three torpedoes could not have struck the ship on the port side without causing a most noticeable port list. Counterflooding of a few starboard voids removed the small port list.

21. At this time she had received six certain bomb hits, none of which had caused any flooding damage. Six certain torpedo hits had been received.

Three of these were in the middle one-half length, two to starboard and one to port. The other three were all in the unprotected bow structure, two to starboard and one to port. MUSASHI was not fatally damaged or necessarily in jeopardy unless additional damage was received. Almost all outboard voids on both sides had been flooded, however, and there was little freeboard remaining at the bow. Much of the AA battery also was dead.

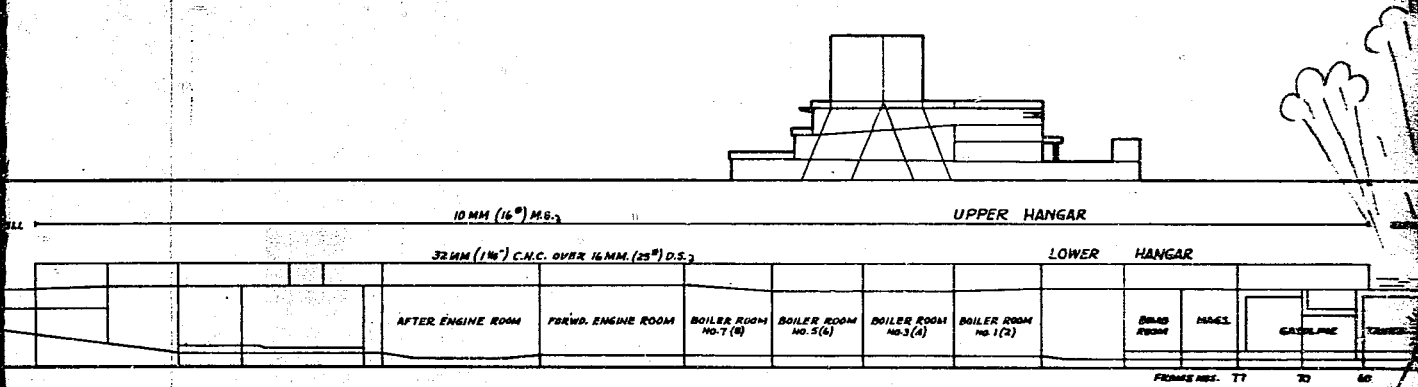
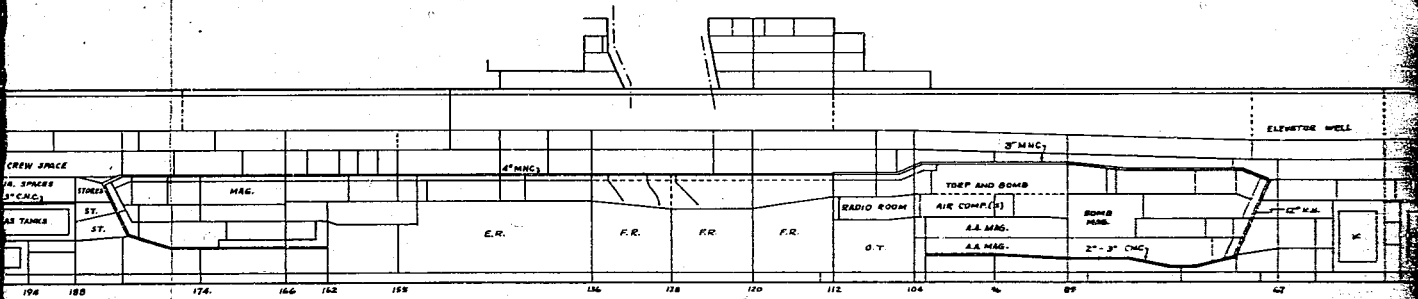
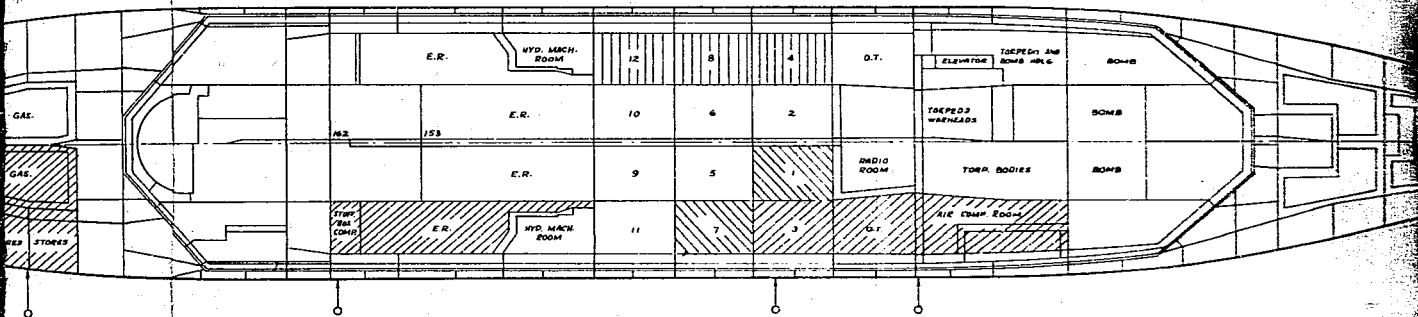
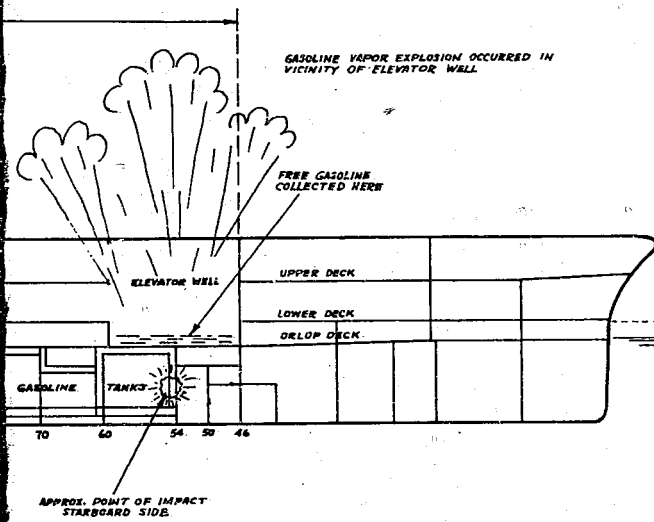
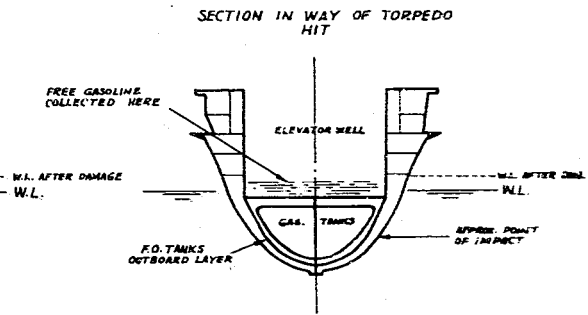
PLATE V

On 19 June 1944, a single submarine torpedo struck TAIHO on the starboard side in way of the forward gasoline tanks. Apparently but moderately damaged, an enormous gasoline vapor explosion occurred some five hours later. Following this, progressive flooding caused her to sink bodily with a heavy starboard list. This occurred about 1½ hours after the explosion.
