The Search, Discovery, and Survey of a World War II Japanese Type "A" Midget Submarine

John C. Wiltshire, Terry Kerby
University of Hawaii • Honolulu, Hawaii USA

Algis N. Kalvaitis
National Oceanic and Atmospheric Administration • Silver Spring, Maryland USA

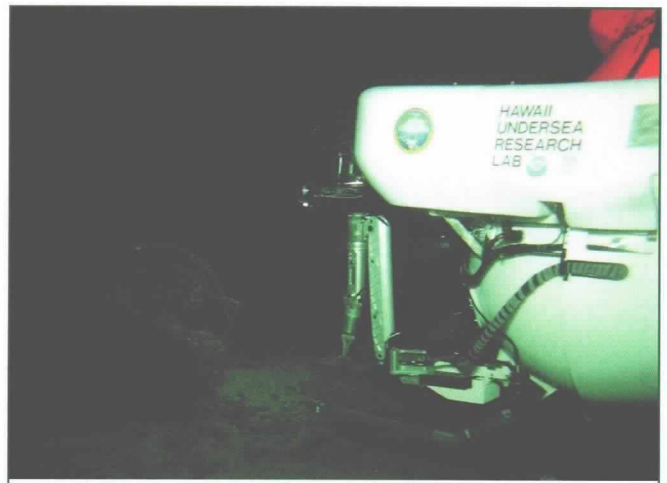
Figure 2. The Hawaii Undersea Research Laboratory's Submersible PISCES IV beside the propellers of the Japanese midget submarine.

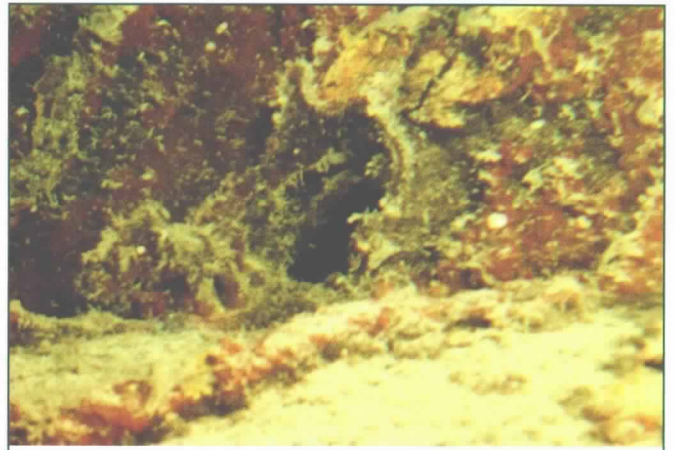
Figure 3. The starboard side of the Japanese midget submarine showing the shell hole from the four inch side gun of the *USS Ward*. The shell impacted at the point where the conning tower joins the pressure hull of the submarine. The shell did not explode but merely penetrated the pressure hull.

There is a sandy berm built up against the starboard side of the hull at the conning tower. This enabled the Pisces IV to get close enough to give the crew a level view at the base of the conning tower. Eyewitness accounts from the *Ward* stated that they saw the second shot from the #3 deck gun hit the submarine at the base of the conning tower. The crew of the Pisces IV discovered a hole at the base of the conning tower exactly where the *Ward's* crew claimed it would be located.

Initially it appeared as though the metal had been blown out from the port side of the conning tower. A closer examination of this extruded lip around the hole shows that it is most likely marine growth. The Pisces IV was able to obtain a close-up image of the hole in the starboard side of the conning tower. This is a clean round hole caused by a projectile that entered from the starboard side. The edge of the hole with torn metal is visible inside the ridge of marine growth. Closer inspection of the hole shows that a projectile may have entered the conning tower between the access trunk and the periscope assembly. From the height that the shell was fired, it is most likely that the projectile went through the base of the conning tower and pressure hull and into the command compartment at the position of the periscope station.

Eyewitness accounts reported that they did not see the shell detonate. There is no distortion in the hull on the port or starboard side that would indicate that the shell exploded when it entered the submarine. If the shell passed through the hull, it would have passed through the lower port side. There is no hole evident on the lower port side of the hull, but there is a sandy berm built up on the port side of the hull aft of the conning tower that could be covering a hole. A closer inspection of the lower port side of the hull should be made to see if there is any sign of an exit hole. It may be possible that the shell did not detonate but splintered when it entered the starboard side of the conning tower and is still inside the submarine.

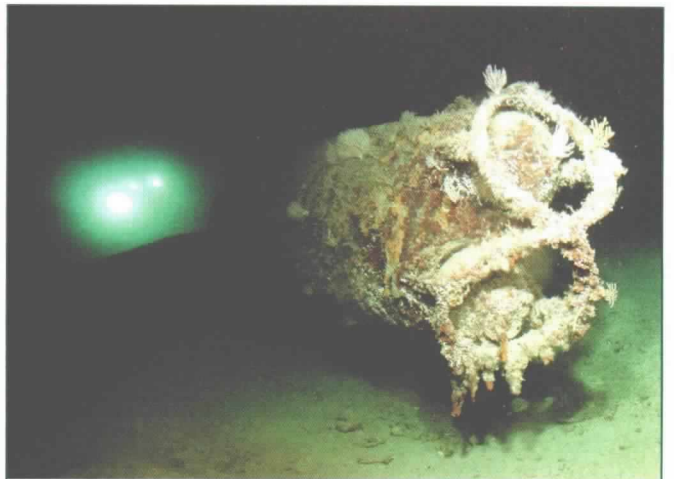
Figure 4. The bow of the midget submarine showing the two torpedoes still in tact, unfired with the torpedo tube covers still in place. In front of the torpedo tubes is a figure eight torpedo guard which also served as a line cutter.

The submarine is in a slight bow-up position. The area at the bow is 1.5 m higher than the stern. Two 6 m long torpedoes were contained in the tubes in this section. The torpedoes were fired by compressed air, and each torpedo reportedly carried about 360 kg of explosives. There is no damage or distortion to the torpedo guards, evidence that the submarine did not impact the bottom bow first and may have landed flat on the keel when it struck the bottom. The torpedo guards are made from steel flat bar material configured in a figure eight (8) design around the torpedoes. These guards were designed to serve as rope cutters. The torpedoes themselves are not visible since the torpedo covers are in place. These covers do not appear to be corroded into the tube.

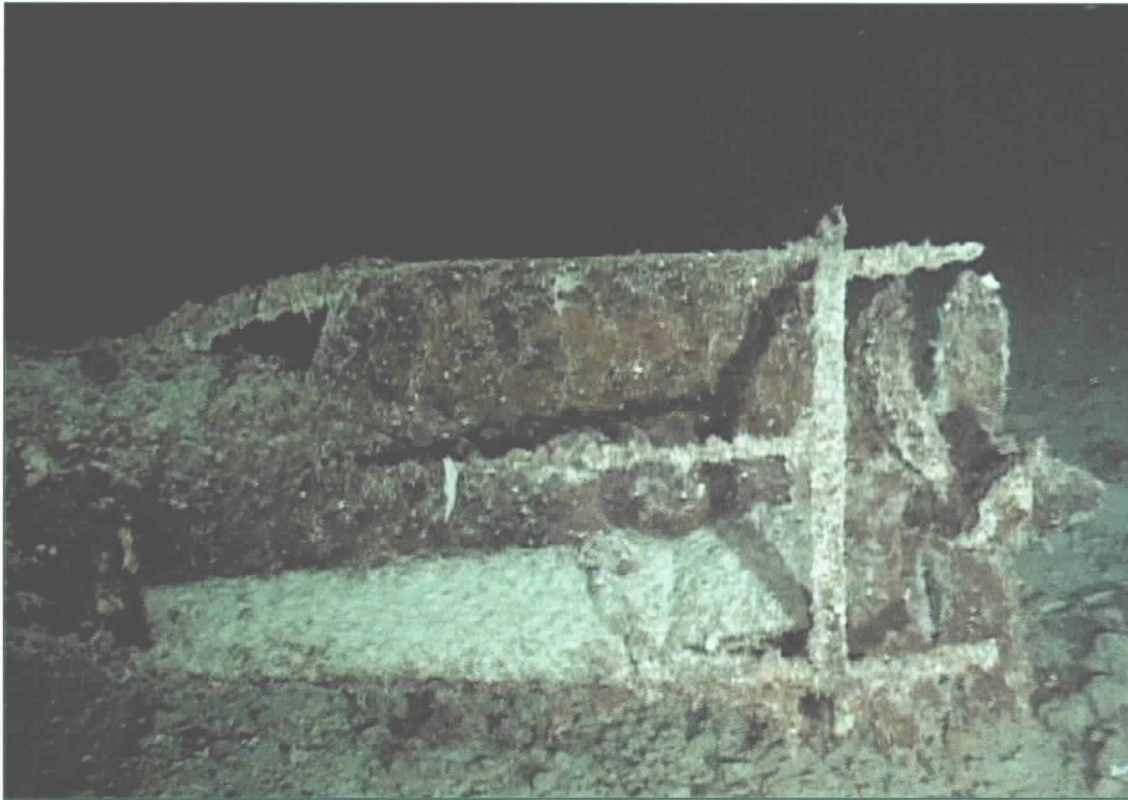
Figure 5. The stern assembly showing the two counter-rotating propellers. It appears that the stern dive planes are in the up position.

The stern assembly shows no signs of impact damage with the bottom. The lower port section of the prop-guard band is missing and appears to be lying on the bottom. The counter-rotating screws are undamaged. The stern planes are in the up position. It appears as though the rudder is slightly to starboard but a closer inspection is needed for confirmation.
