The Search, Discovery, and Survey of a World War II Japanese Type "A" Midget Submarine

John C. Wiltshire, Terry Kerby
University of Hawaii • Honolulu, Hawaii USA

Algis N. Kalvaitis
National Oceanic and Atmospheric Administration • Silver Spring, Maryland USA

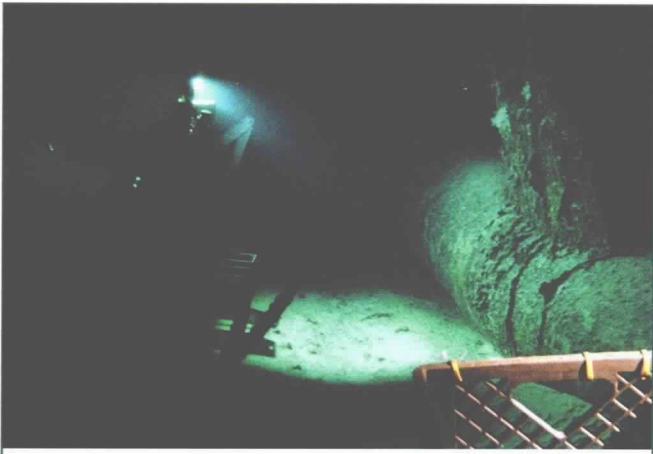
Figure 1. The Hawaii Undersea Research Laboratory's submersible PISCES V at the moment of discovery of the type A Japanese midget submarine which was sunk off the mouth of Pearl Harbor on December 7, 1941.
